GEOCHEMICAL CHARACTERIZATION OF ACIDIC SAND USED AS URBAN CONSTRUCTION FILL MATERIAL

J.H. Rule

**Department of Ocean, Earth
& Atmospheric Sciences
Old Dominion University
Norfolk, VA 23529**

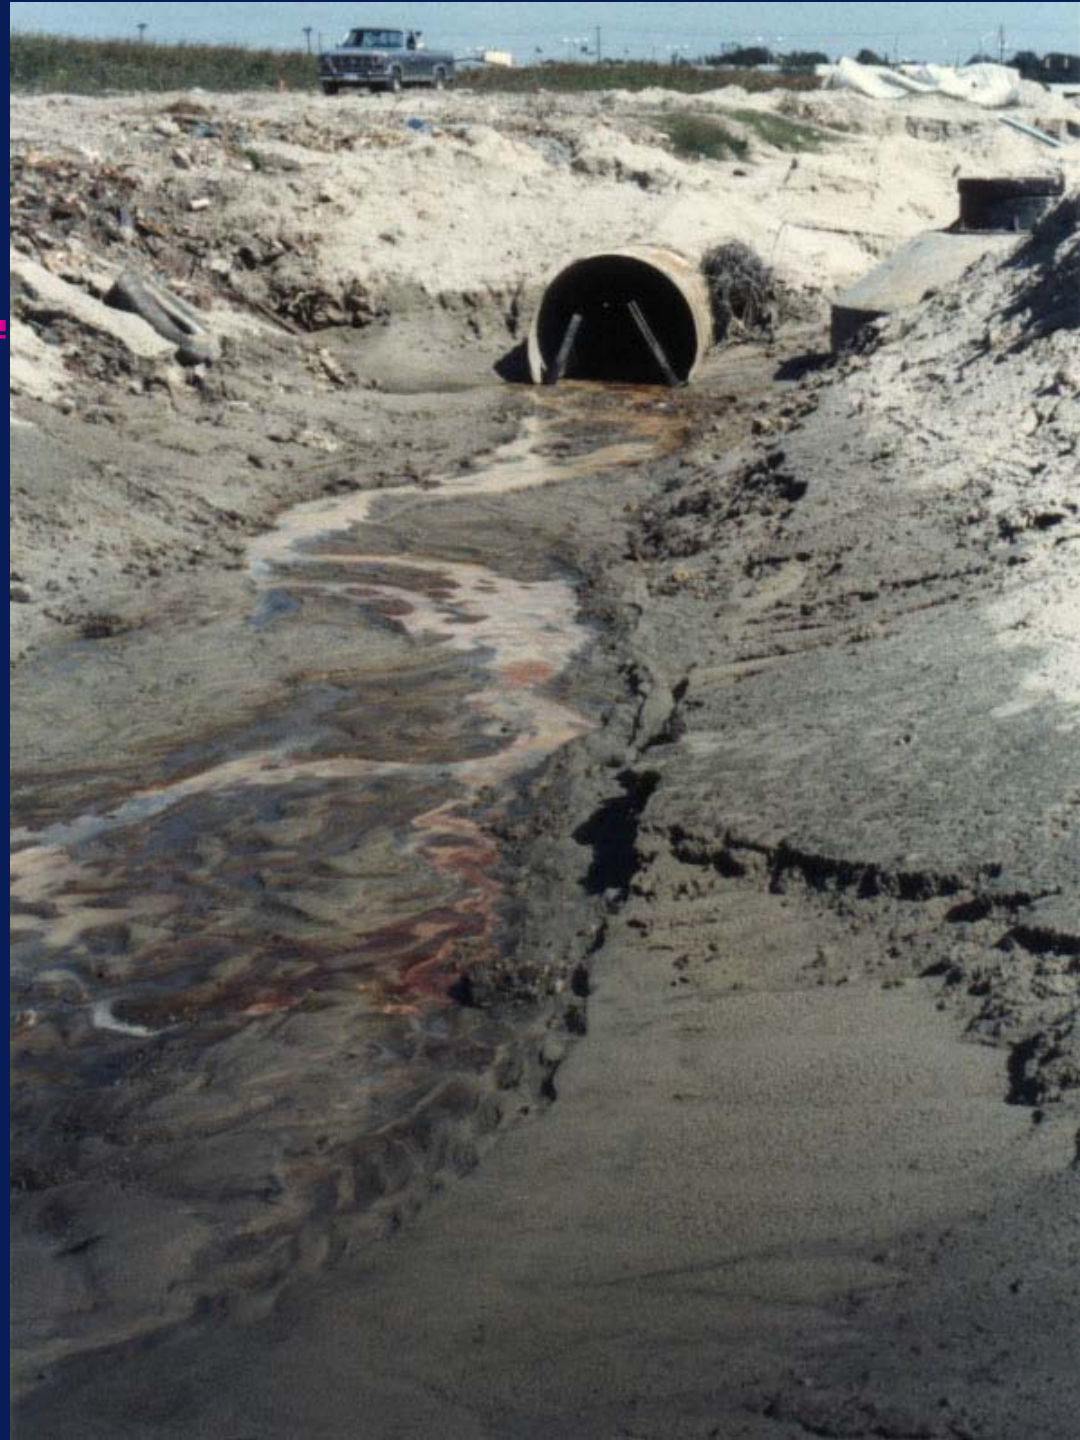
ROAD FILL SITE

Closer view of groundwater with mixture of leachate acid reaction products and. Note LF debris and stain on pipe.

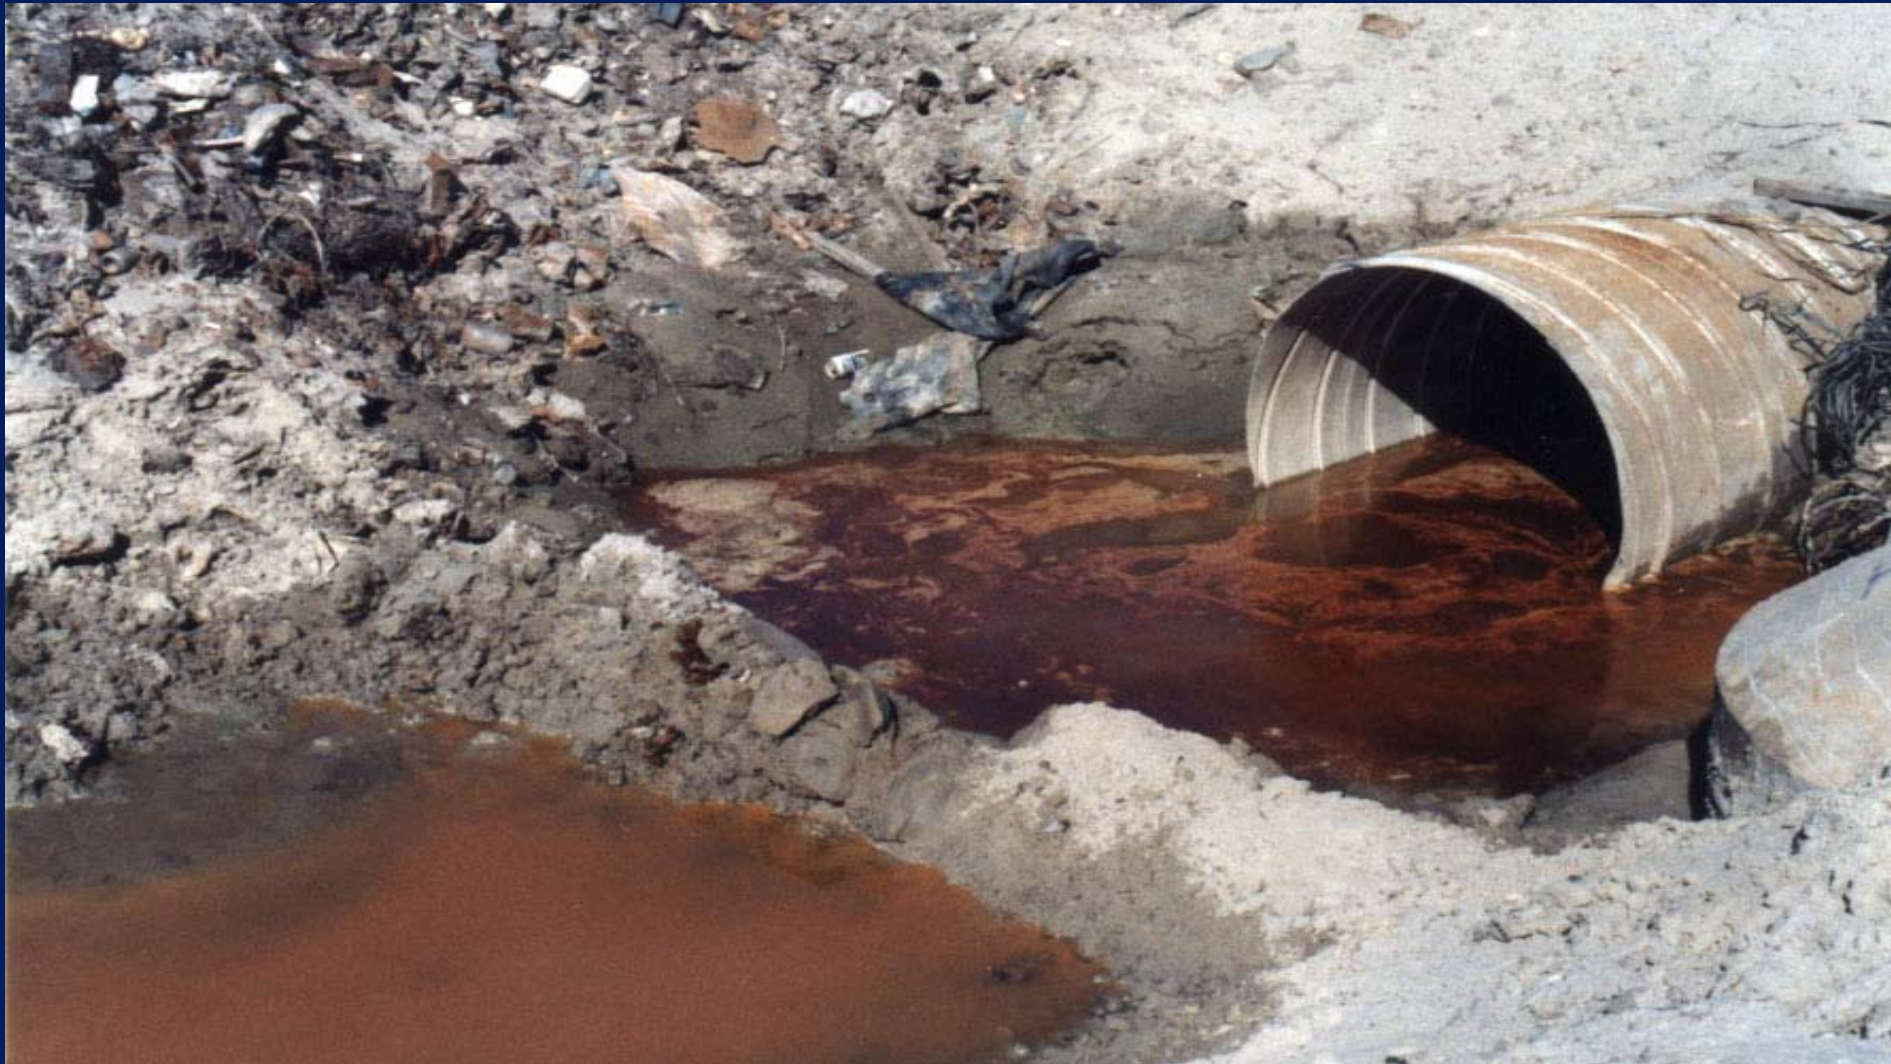
ROAD FILL SITE

Corrosion of pipe is evident

- **Corrosion tests of the Al storm drain material predicted a corrosion rate of 0.98 mm in three months.**
- **In some cases corrosion of 1.5 mm of material occurred in the fill site.**
- **Corrosion tests predicted that severe pipe failure would occur within one year.**
- **All Al storm drain was removed and replaced within one year of the study.**

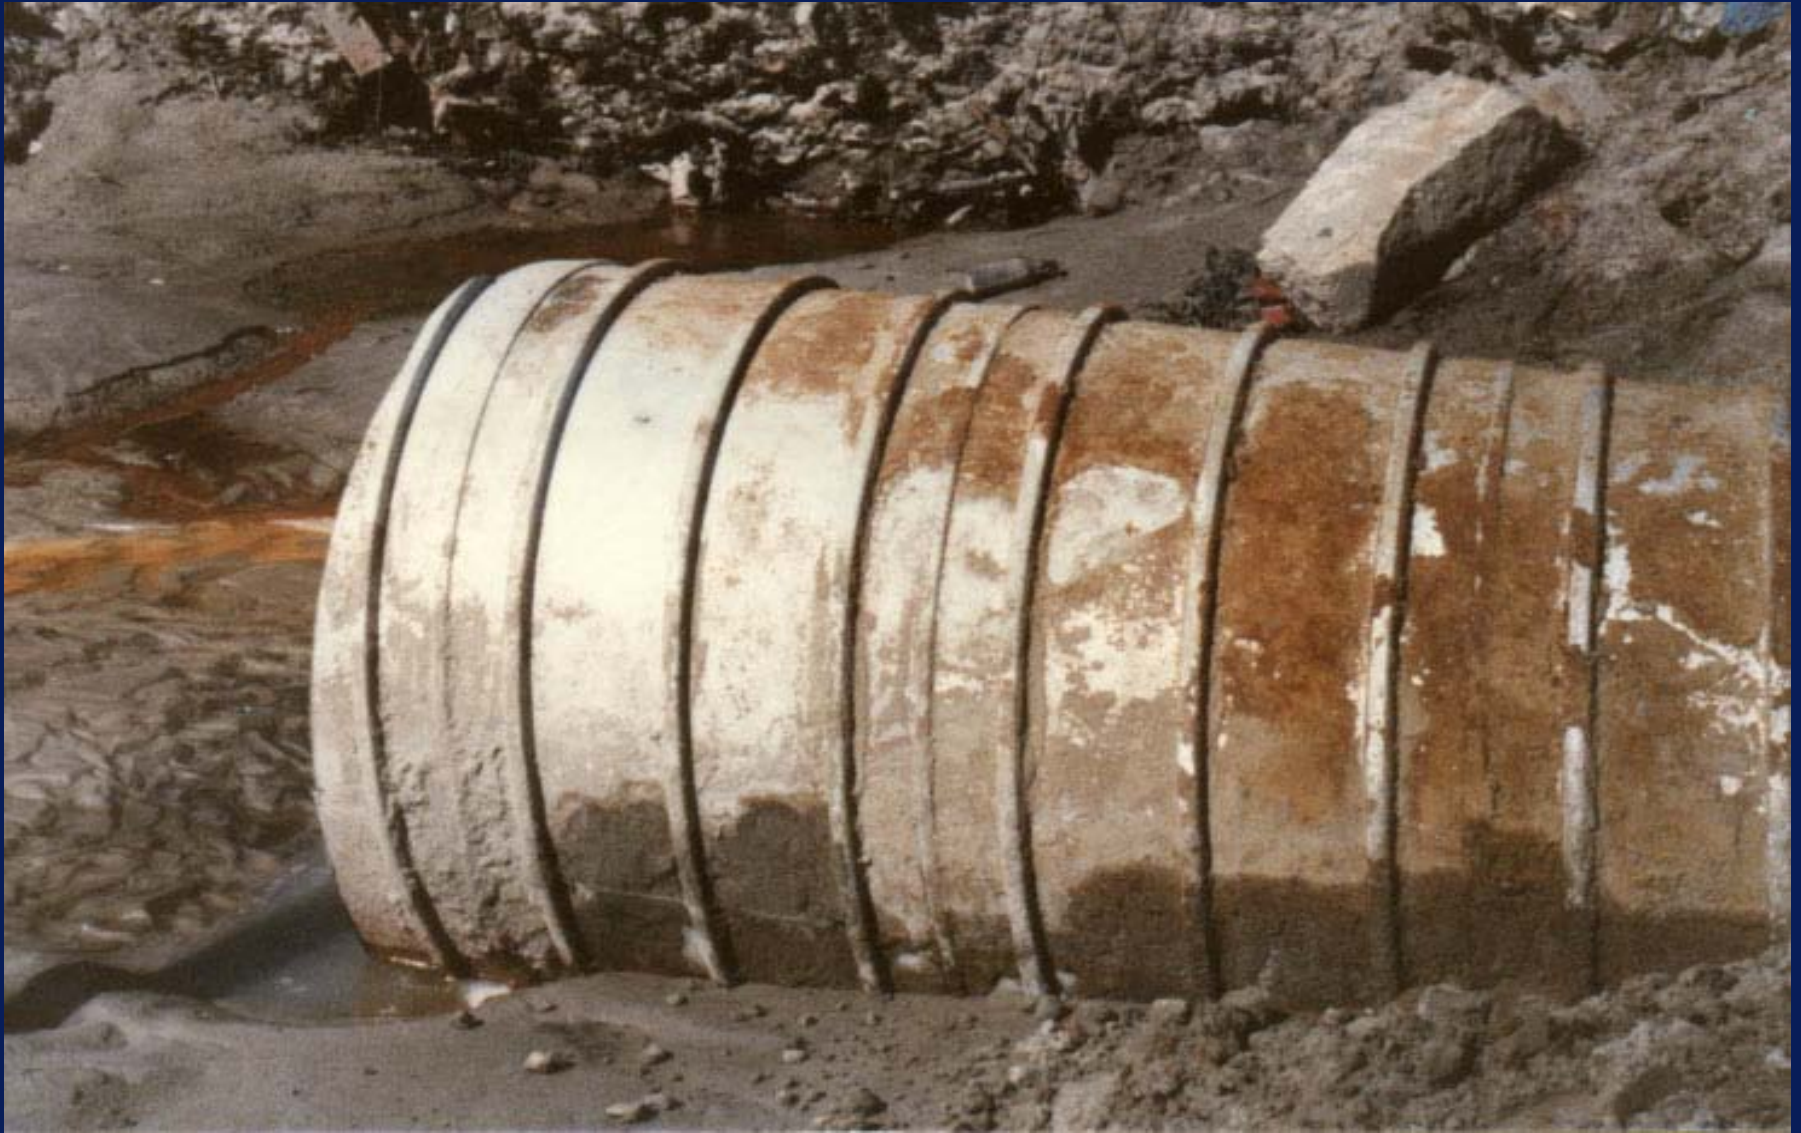
ROAD FILL SITE

Close-up view of severe pipe corrosion

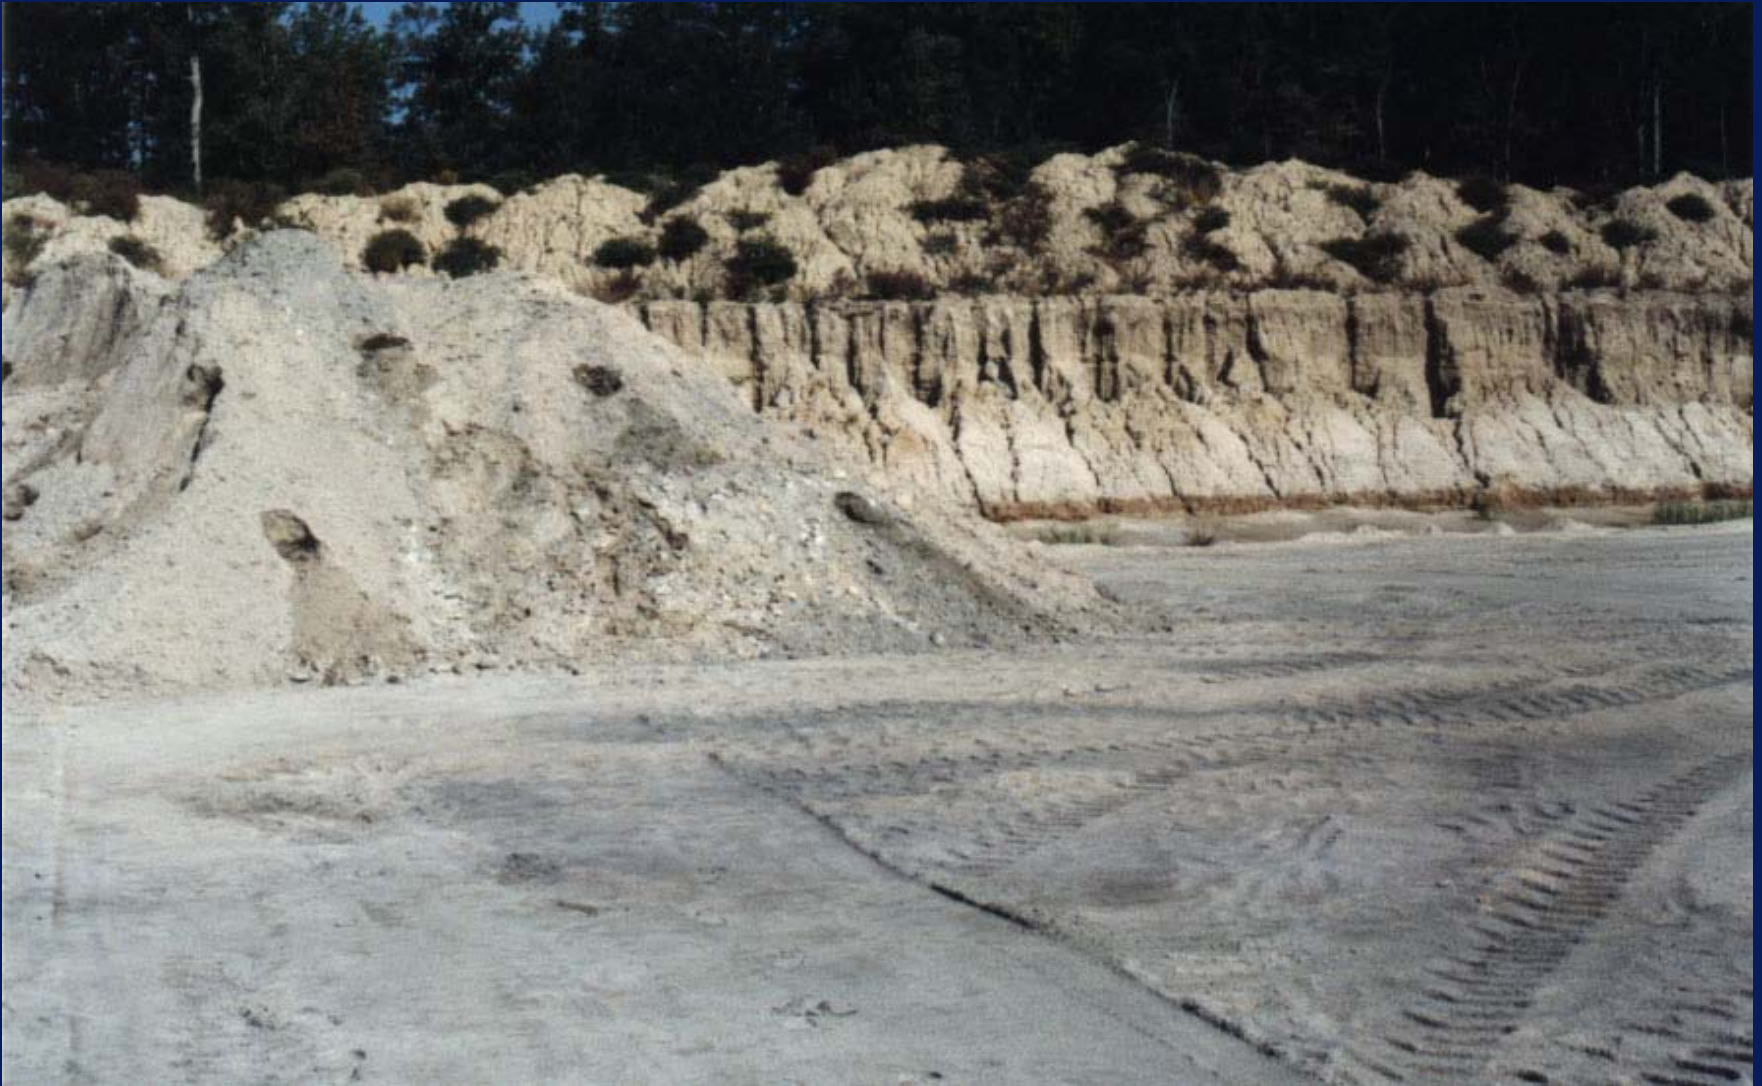
SAND PIT

Note organic-rich layer at top of the sequence in the background and iron-stained sand in foreground.

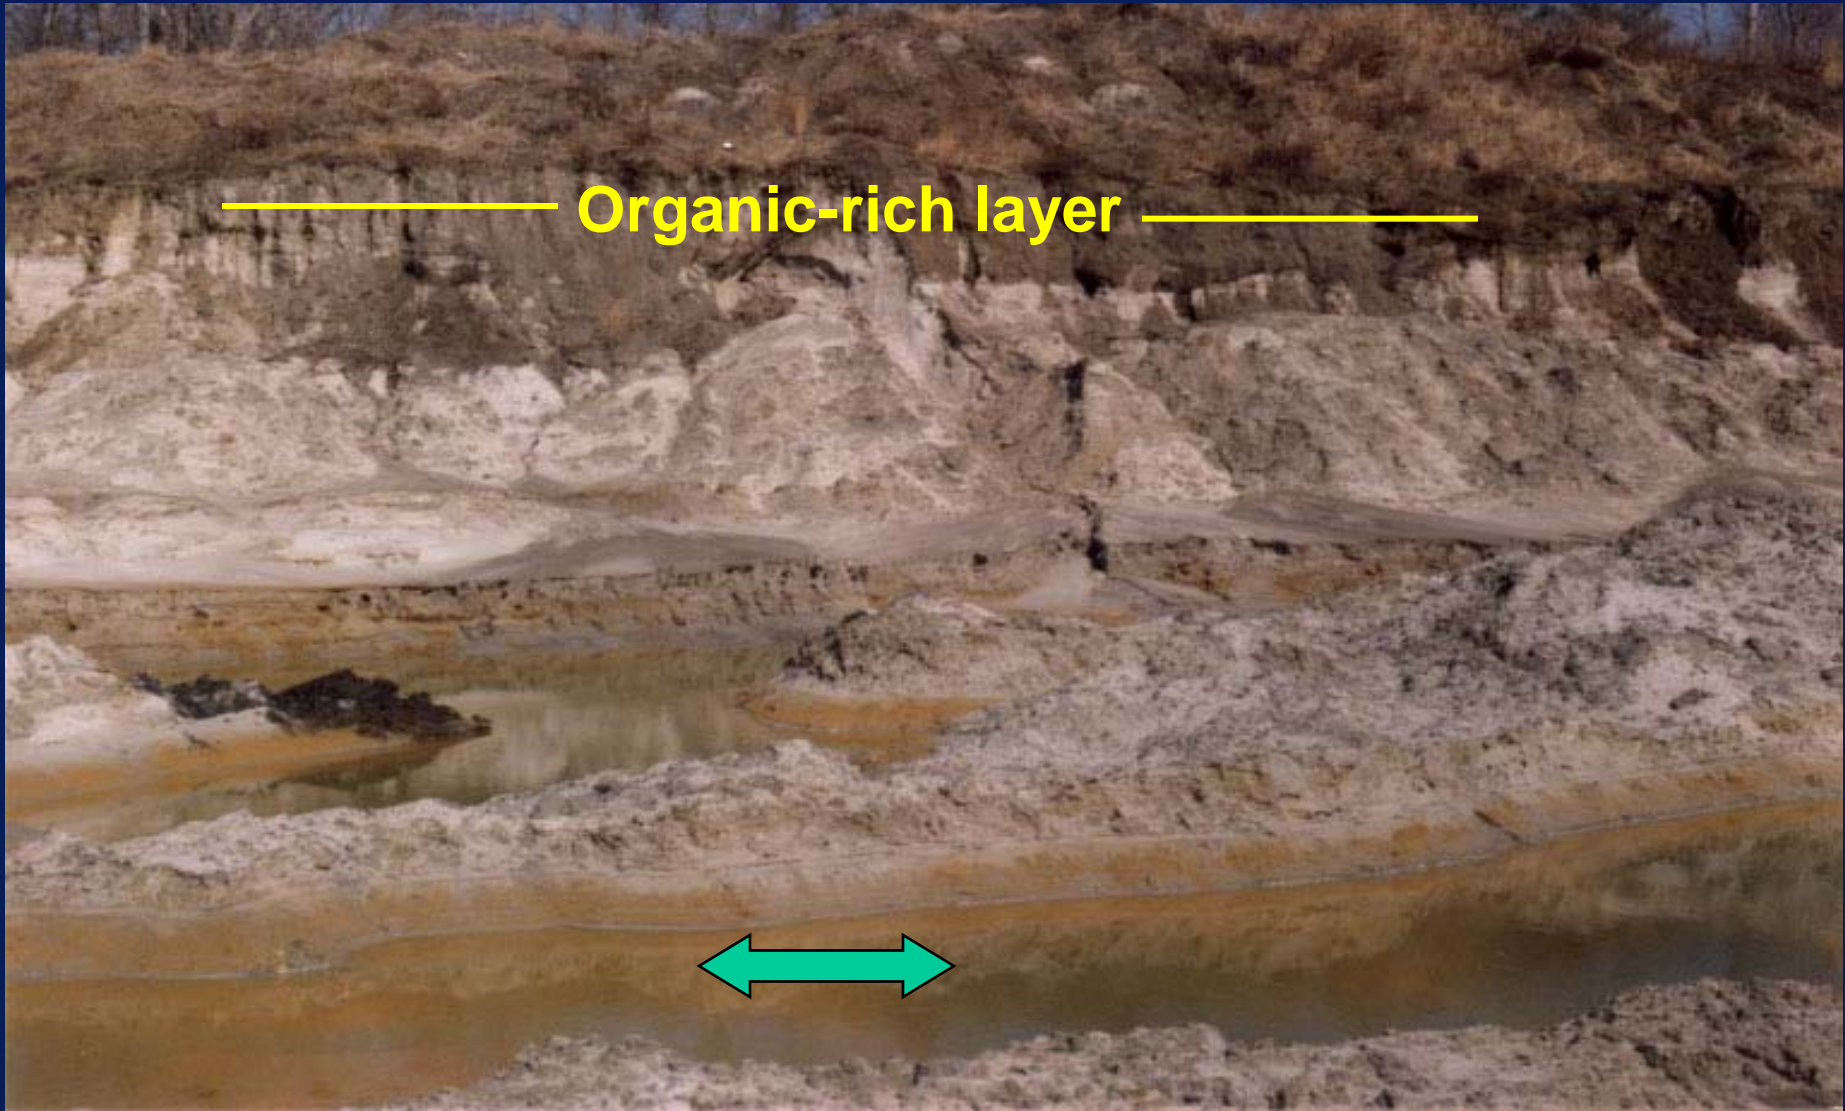
SAND PIT

Acid water with Fe-oxide precipitates; Note acid-tolerant algae in the foreground and well-leached sand in the background.

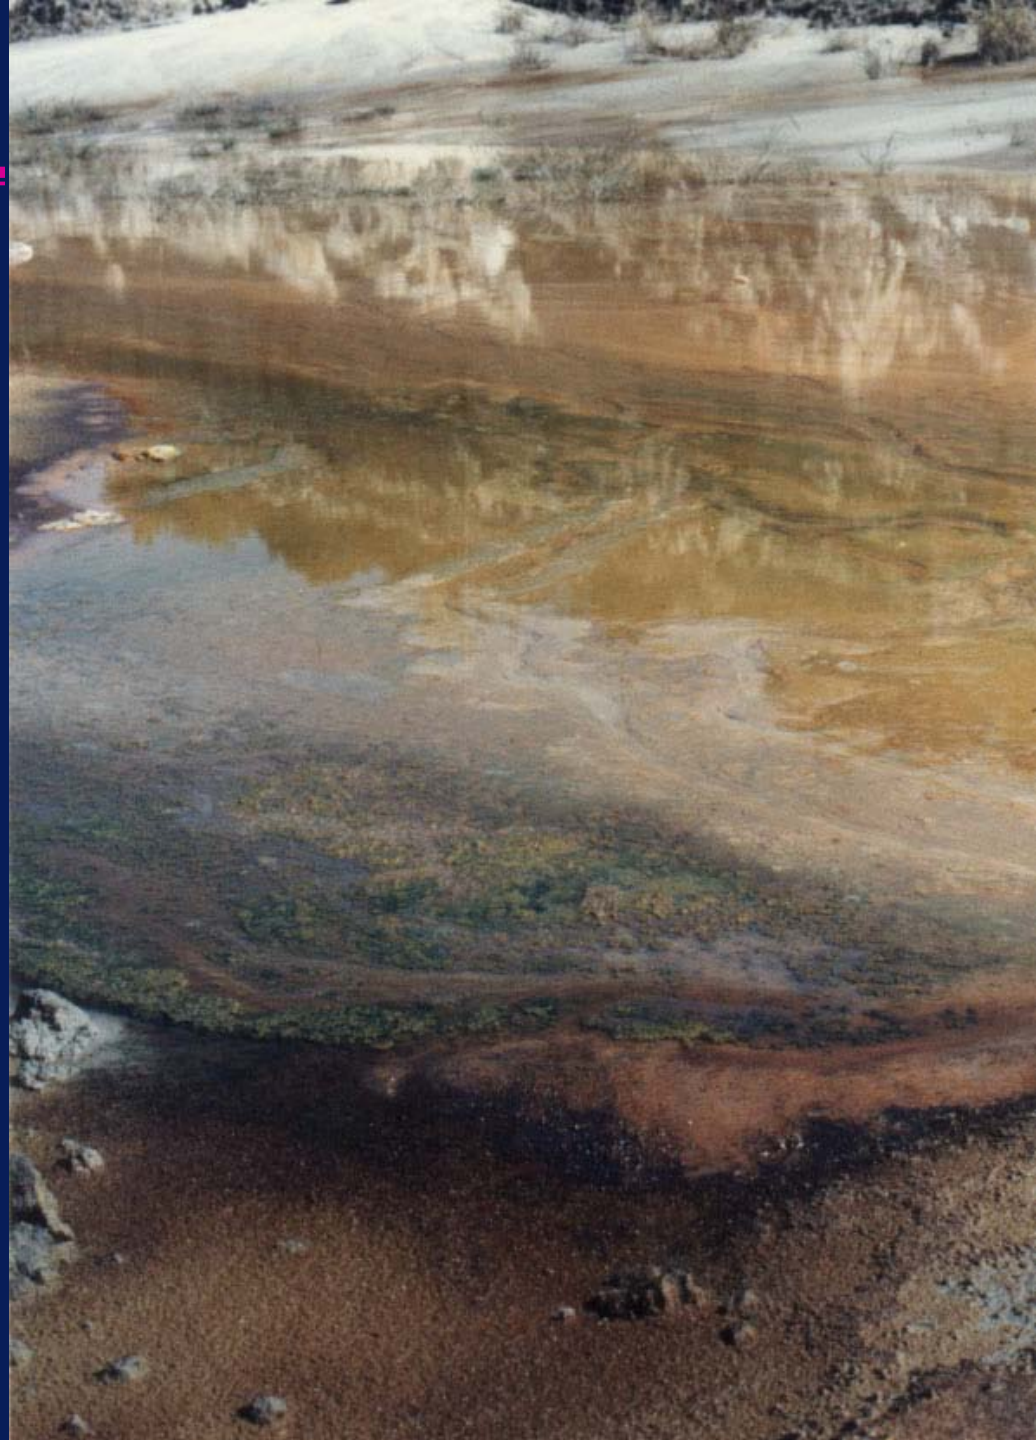
SAND PIT

Acidic water with
Fe-oxide precipitation

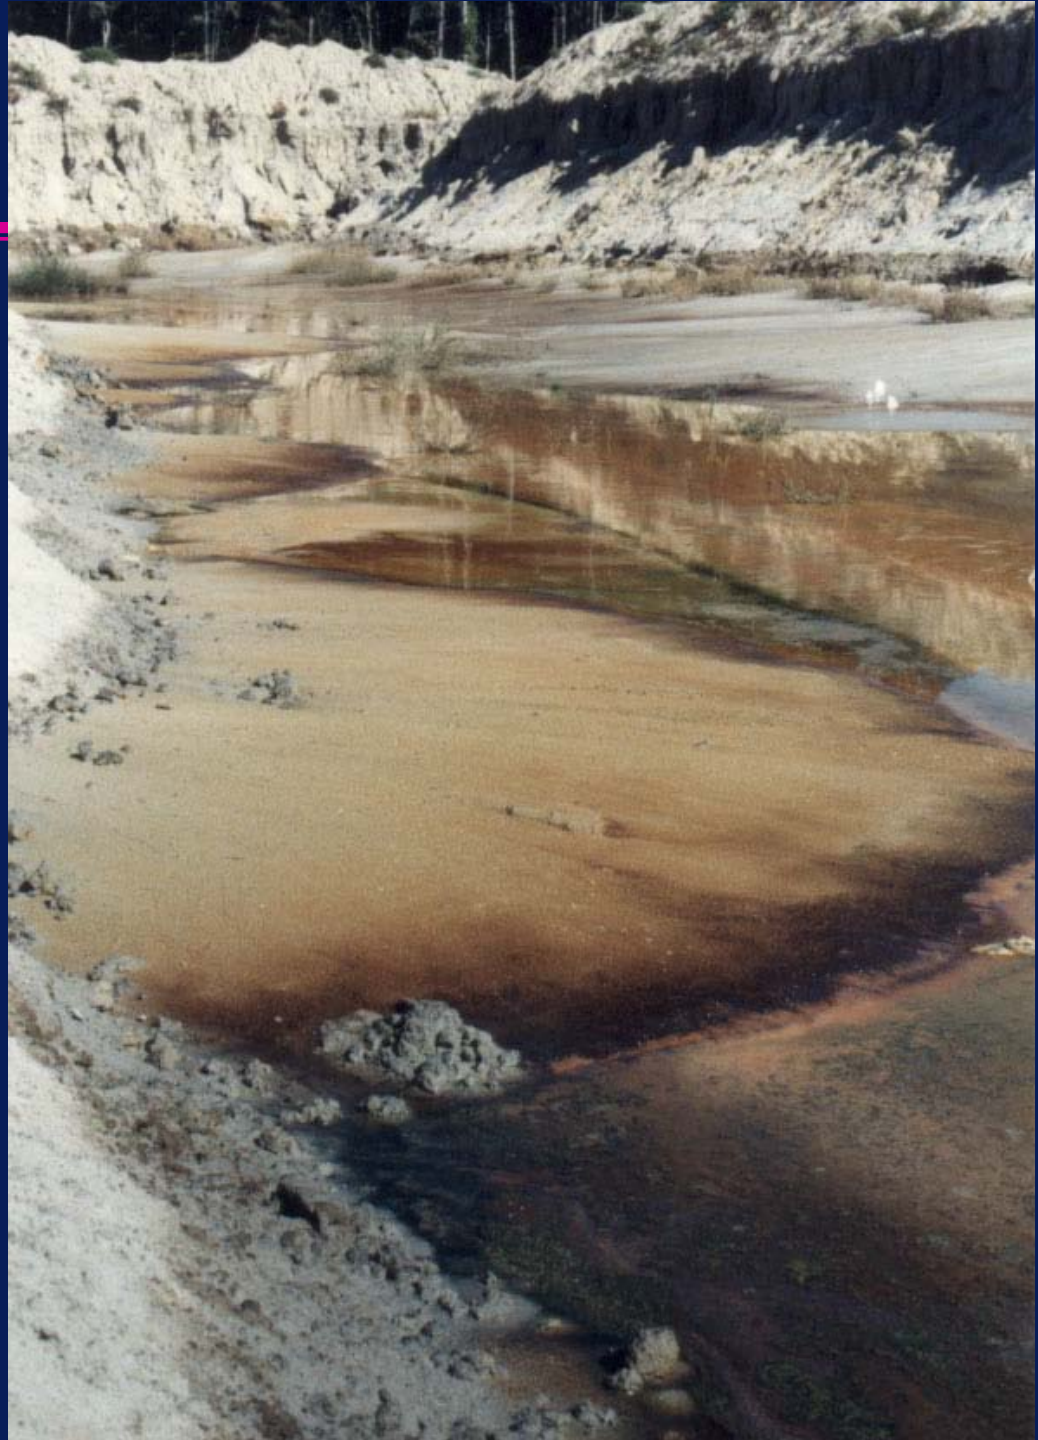
SAND PIT

Sands layered with organic-rich reduced muds.

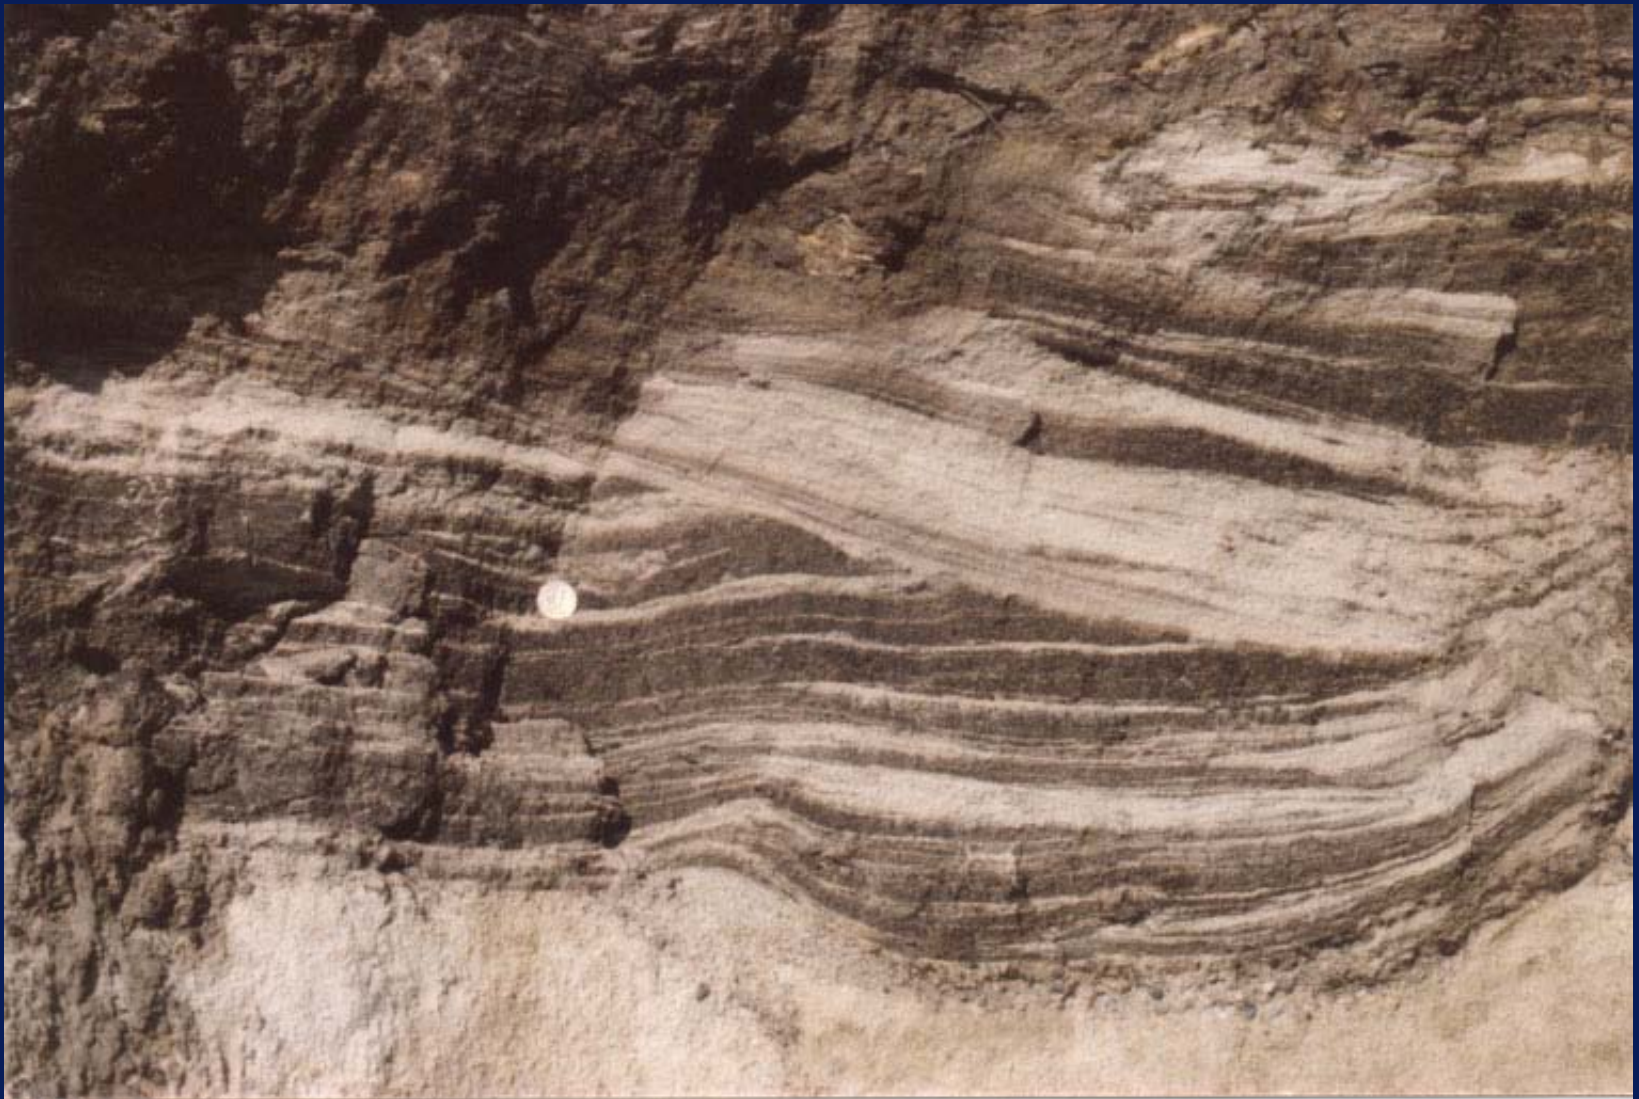
SAND PIT

Reduced layer containing well-preserved organic matter.
