SPILL PREVENTION, CONTROL, AND COUNTERMEASURES (SPCC) PLAN

Prepared for: Old Dominion University
Env. Health & Safety
Spong Hall, suite 2501
Norfolk, Virginia 23529

Prepared by: Bay Environmental
648 Independence Parkway
suite 100
Chesapeake, VA 23320

March 2021

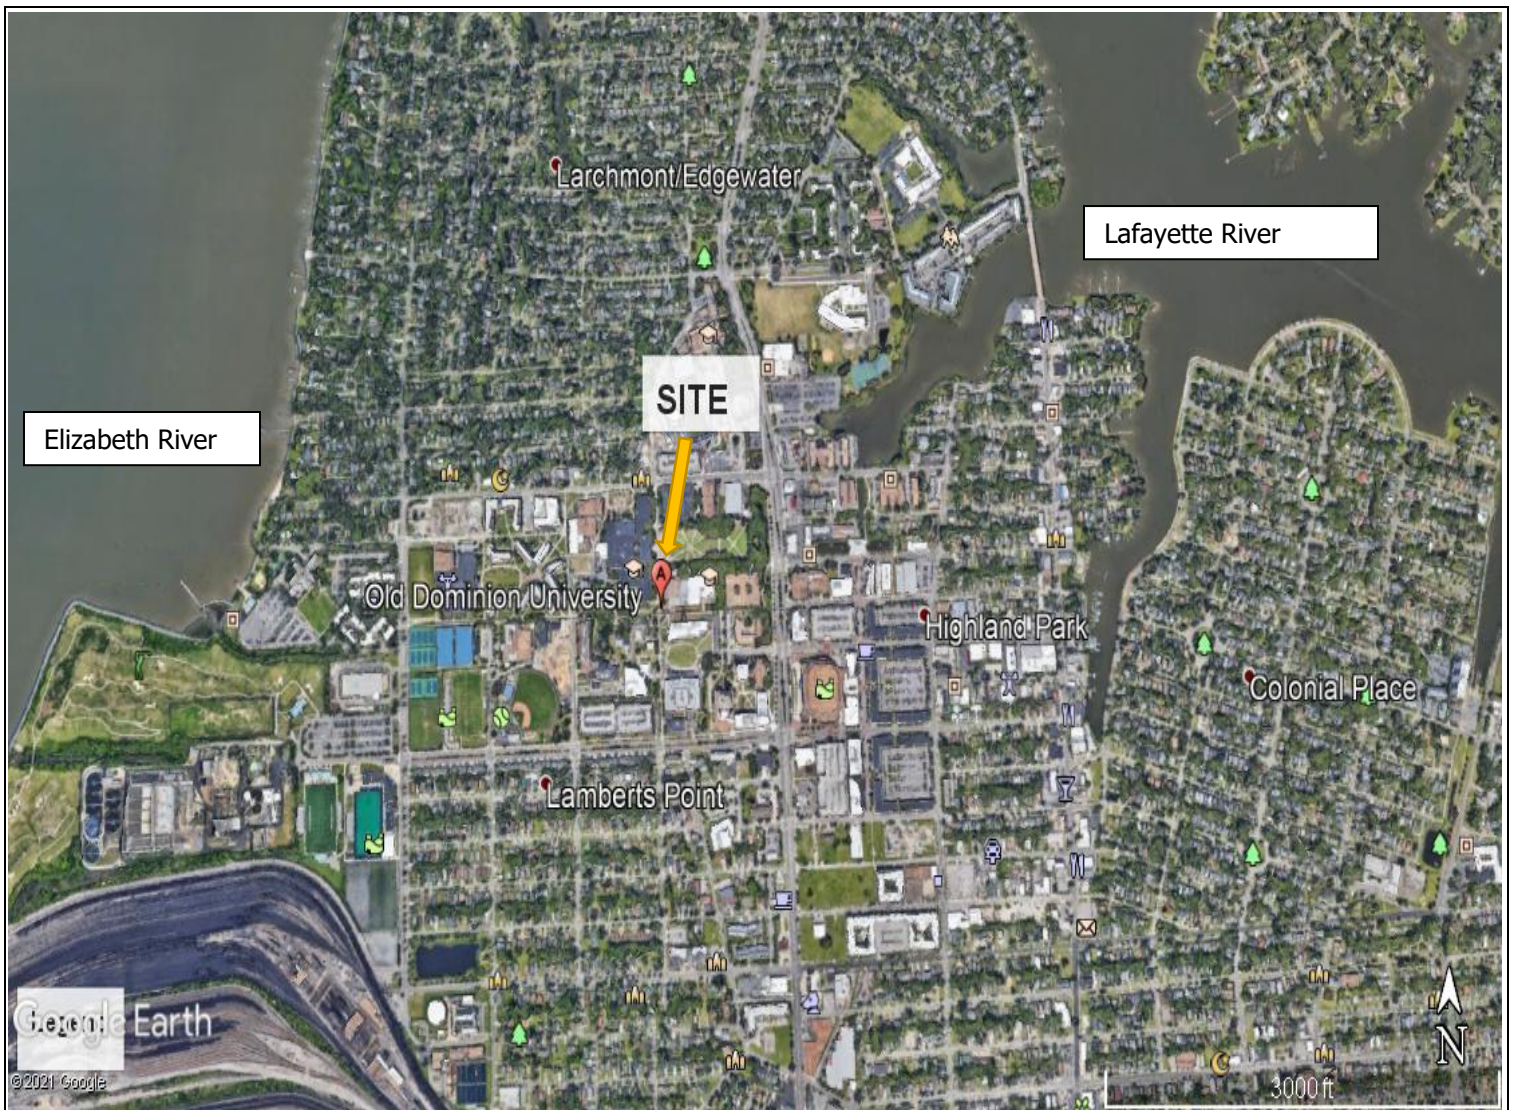
Figure 1

Old Dominion University
Norfolk, Virginia

Old Dominion University is a state-assisted educational institution located in the city of Norfolk, Virginia. This institution is comprised of various buildings and parking lots and operates as a higher education institute for on-site and commuter students. The University campus currently handles and stores petroleum products in the form of #2 fuel oil and gasoline. The figures in Attachment A show the property, drainage structures, buildings on site, and oil storage locations.

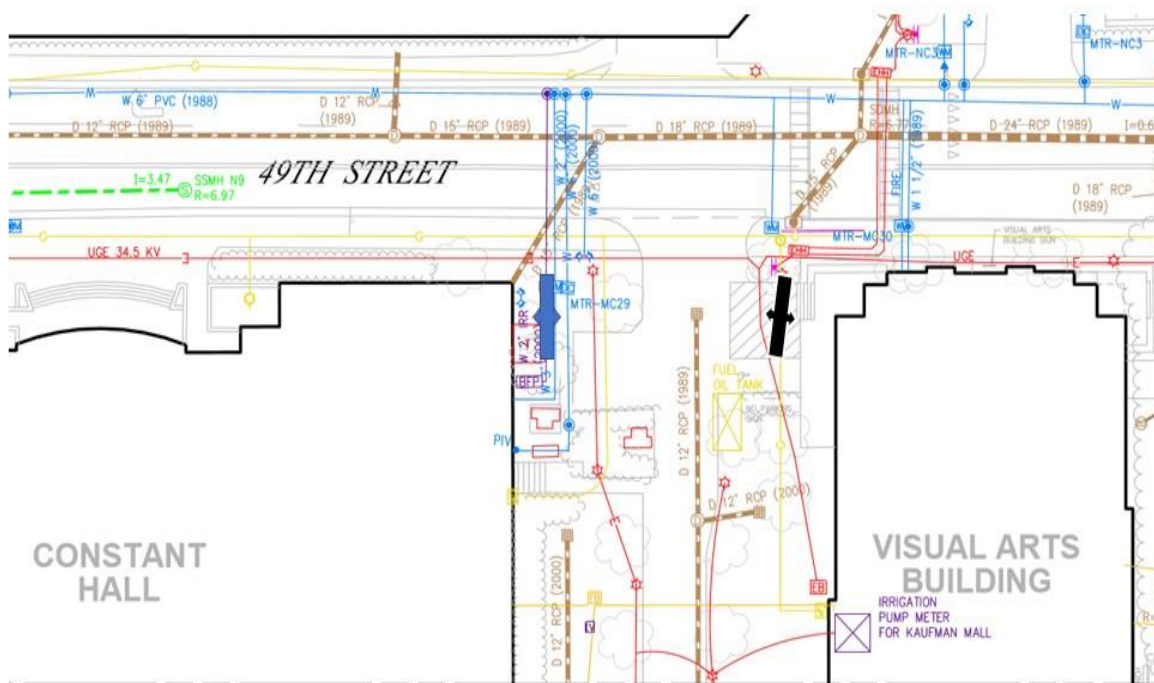
Figure 3

<p>NOT TO SCALE</p> <p>Date: 02/19/2021</p> <p>Office of Environmental Health & Safety</p>	<p>Constant Hall & Visual Arts Building</p> <p>Old Dominion University</p> <p>Norfolk, Virginia</p>	<p><u>Legend:</u></p> <p>Fuel tank (AST)
