GEOCHEMICAL CHARACTERIZATION OF ACIDIC SAND USED AS URBAN CONSTRUCTION FILL MATERIAL

J.H. Rule

**Department of Ocean, Earth
& Atmospheric Sciences
Old Dominion University
Norfolk, VA 23529**

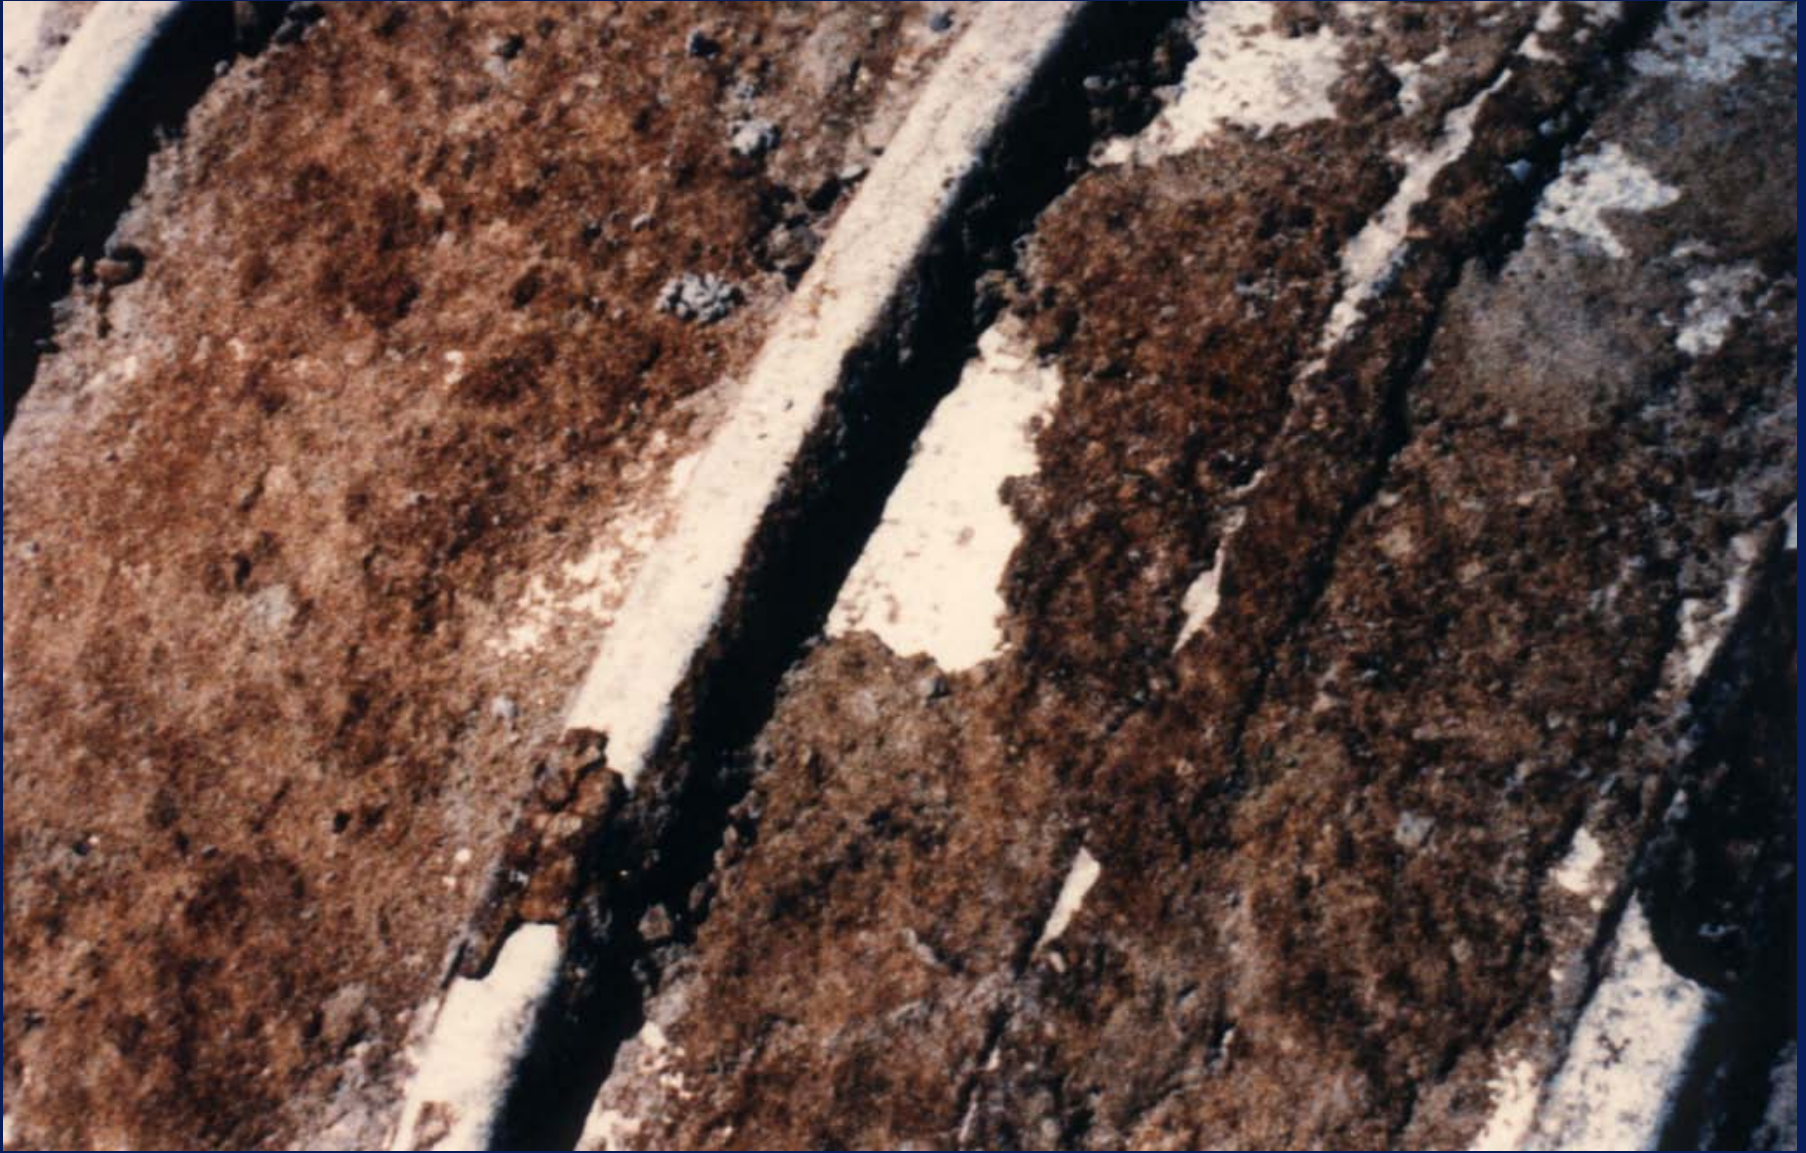
SCHEMATIC OF ROAD FILL SITE

Three months later there was significant pipe corrosion and in localized areas complete pipe failure.

- **Corrosion tests of the Al storm drain material predicted a corrosion rate of 0.98 mm in three months.**
- **In some cases corrosion of 1.5 mm of material occurred in the fill site.**
- **Corrosion tests predicted that severe pipe failure would occur within one year.**
- **All Al storm drain was removed and replaced within one year of the study.**

- **Sand from the borrow pit caused pipe deterioration.**
- **Groundwater from the adjacent landfill was a source of neutralization of the acidity from the sand fill, but had no overall impact on corrosion rates.**
- **The source of the acidity was organic-rich muds from an overlying Pleistocene swamp deposit.**

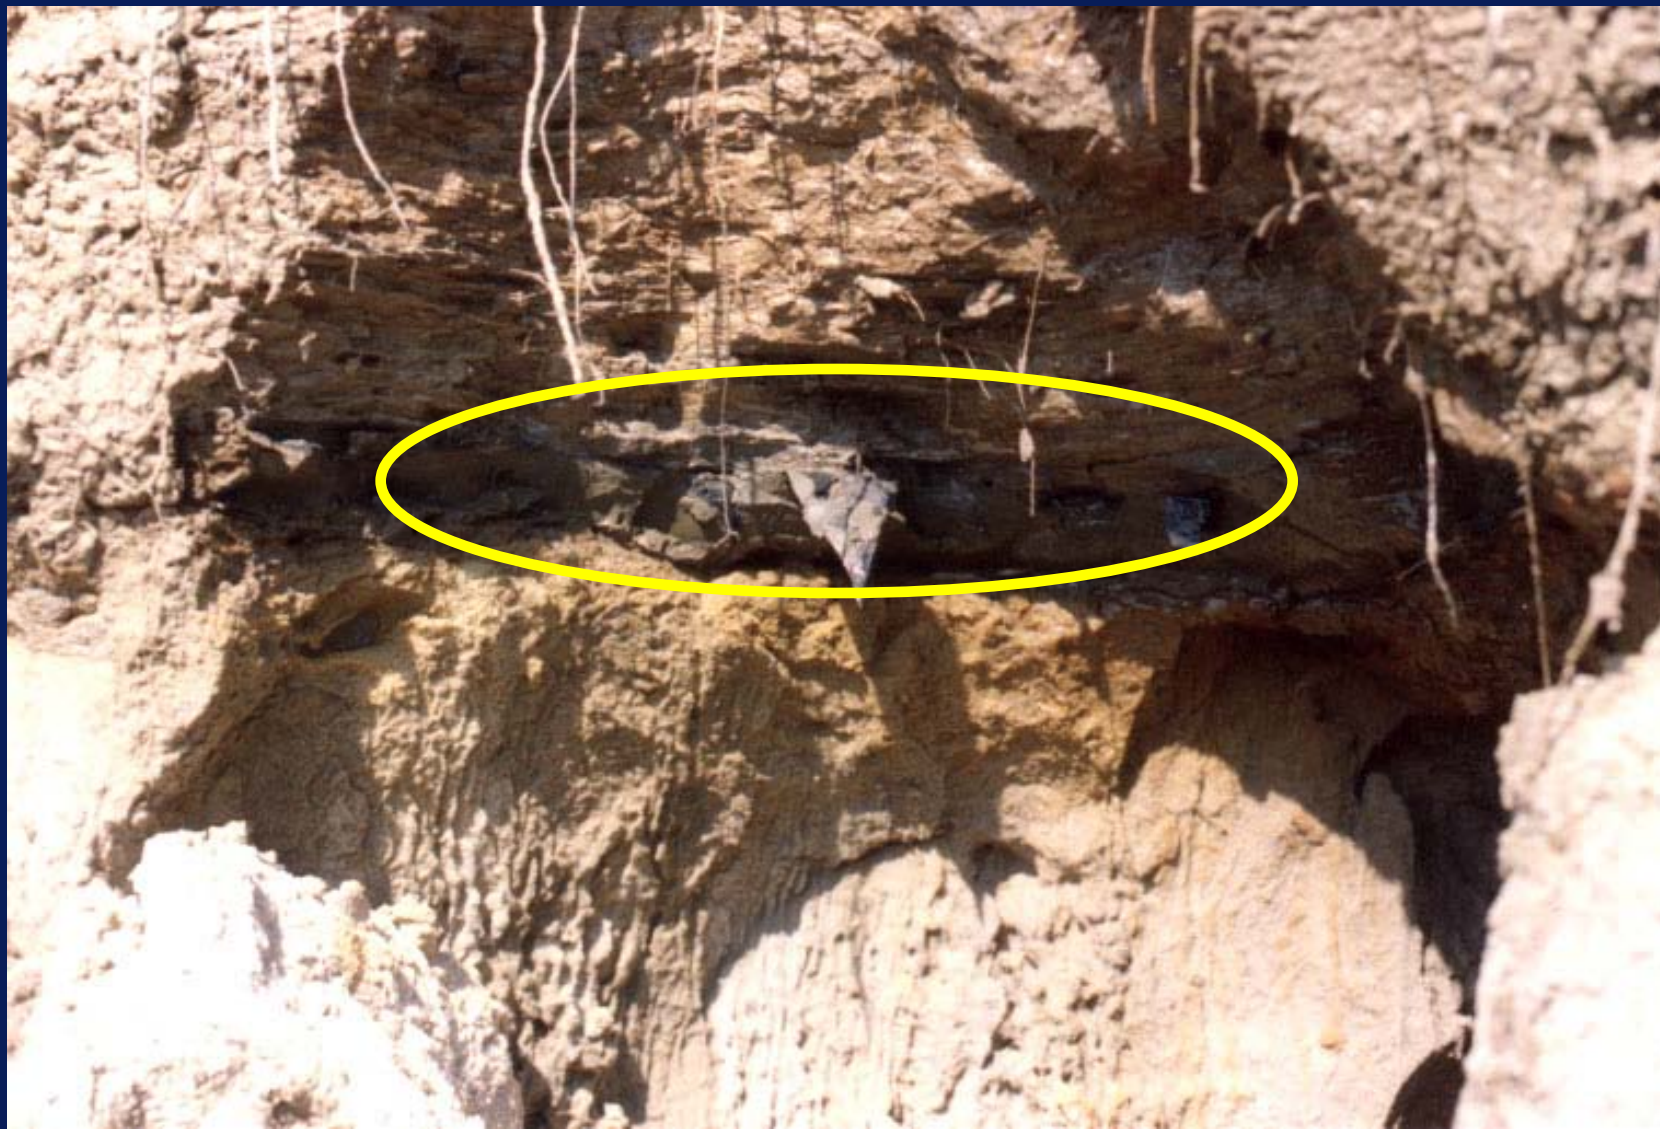
SCHEMATIC OF SAND PIT

- Sulfide reserves in this type of sand are sufficient to generate acid production over a several month period.
- Fill sands from these types of depositional environments should be tested prior to emplacement.
- Corrosion rates of reactive material can be successfully predicted from laboratory test results.

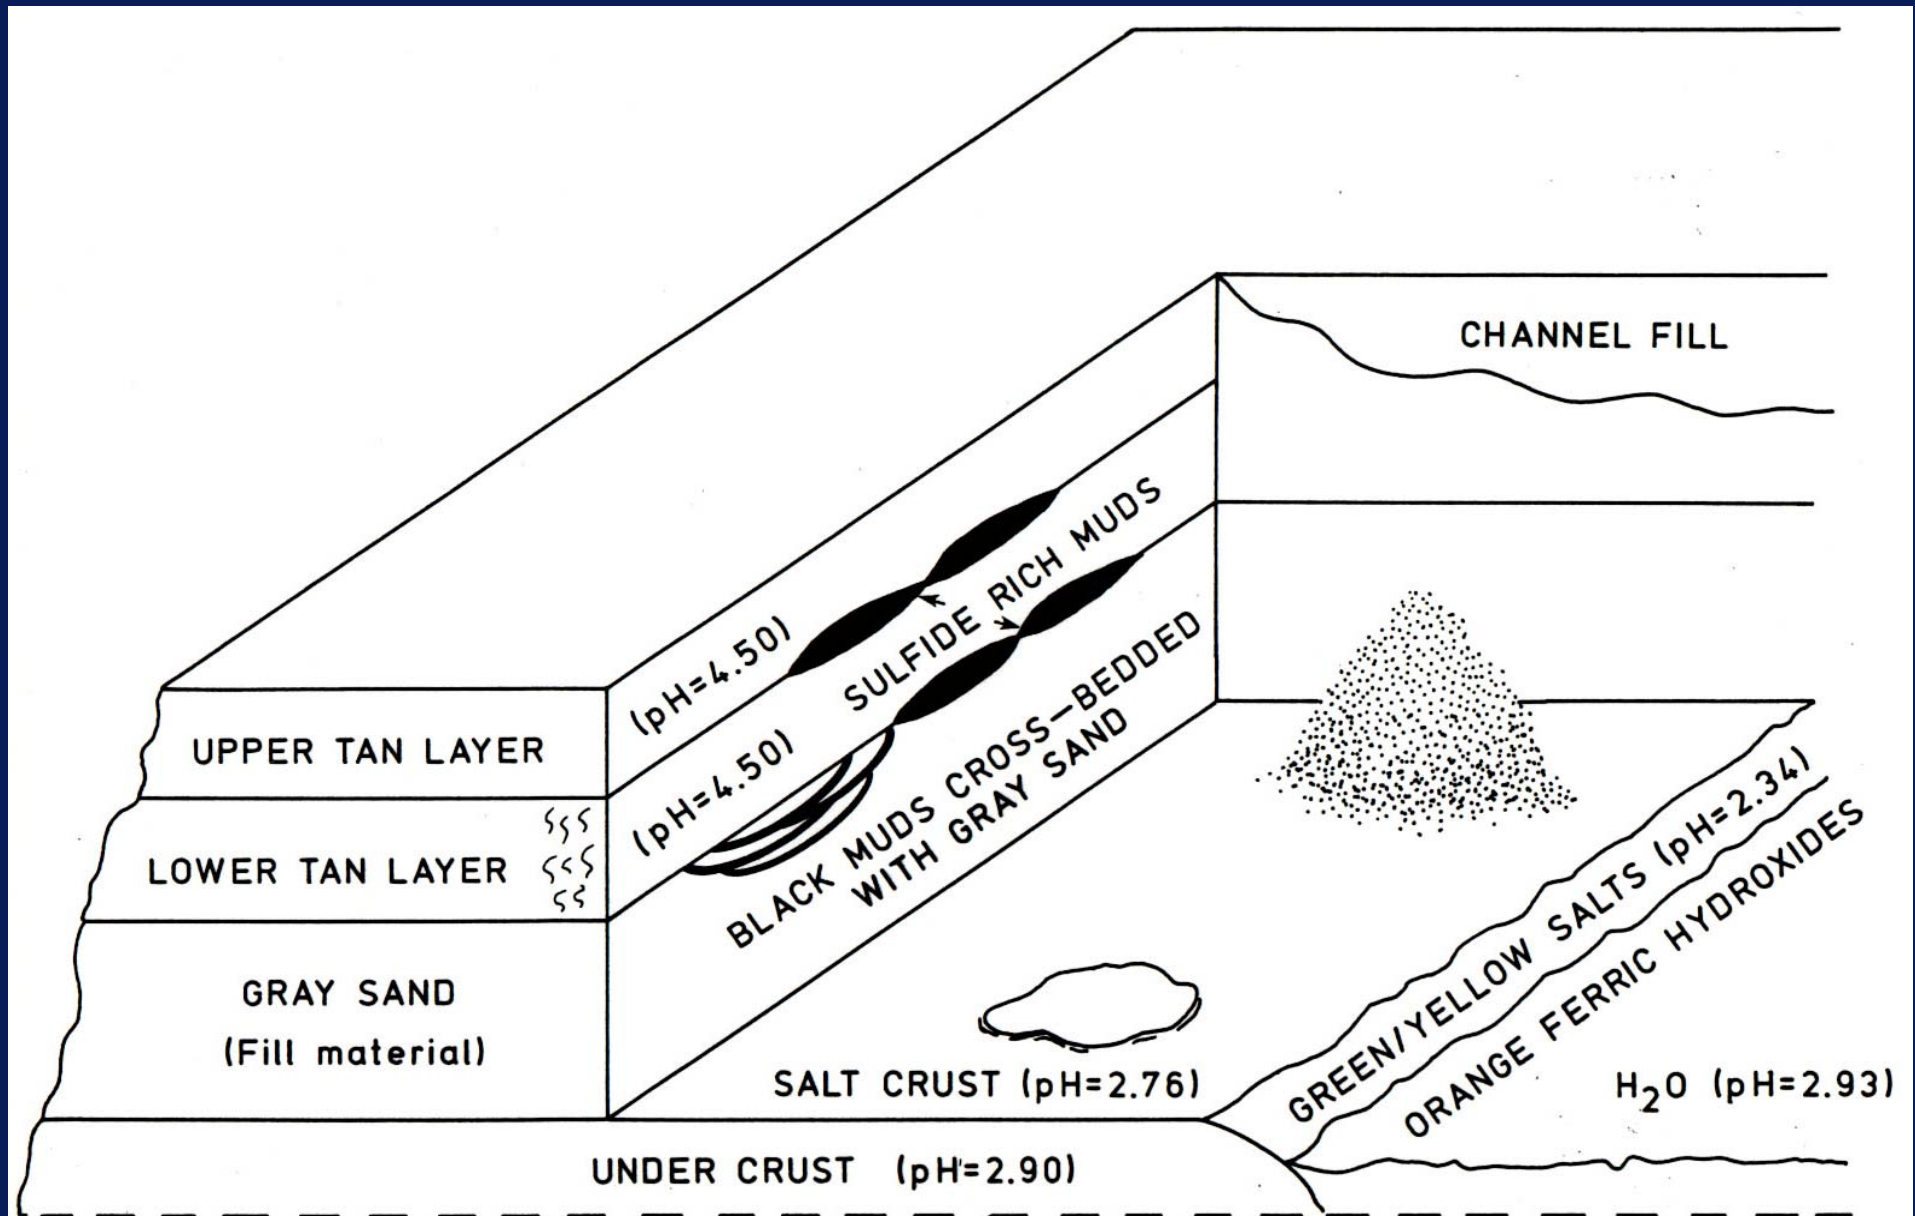
MECHANISM OF SULFIDE ACCUMULATION

1. SULFIDES OXIDIZED TO SULFATES
2. SULFATES LEACH TO BELOW WATER TABLE
3. SULFATES REDUCED TO SULFIDES AND ACCUMULATE OVER TIME

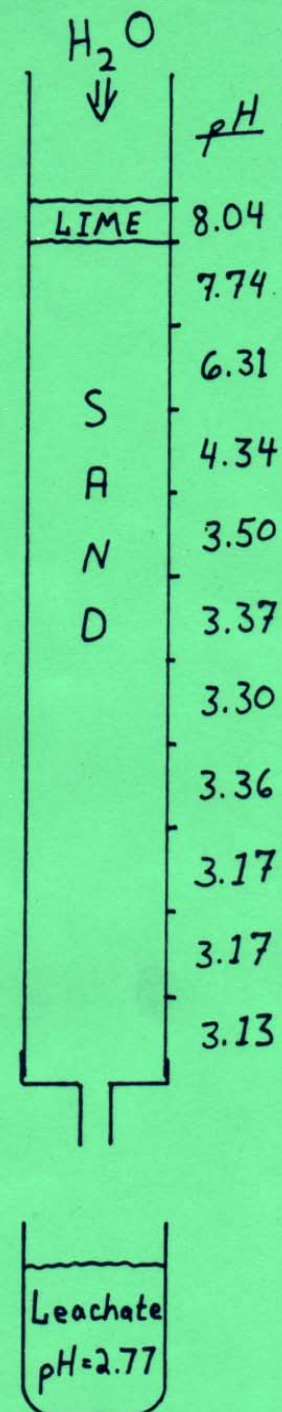
SEDIMENT (SAND) pH and Eh

Sample	pH	Eh (mv)
Lowery Road 1	2.8	+376
Lowery Road 2	2.7	+406
Sand Pit 1	2.5	+386
Sand Pit 2	2.5	+386
